## ACCIDENT CASE STUDY

## COLGAN AIR FLIGHT 3407

## BACKGROUND INFORMATION

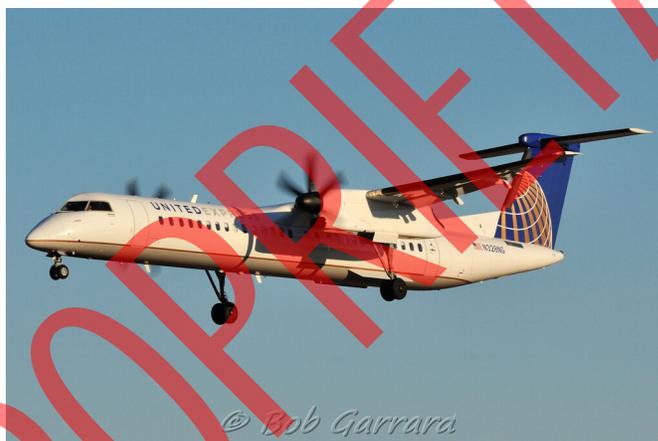
<b>Date</b>	February 12, 2009
<b>Time</b>	10:17 p.m.
<b>Airline</b>	Colgan Air, operating as Continental Connection Flight 3407
<b>Aircraft</b>	Bombardier DHC-8-400
<b>Location</b>	Instrument approach to Buffalo-Niagara International Airport, New York
<b>Severity</b>	Crashed into a residence in Clarence Center, New York, about 5 nautical miles northeast of the airport. The two pilots, two flight attendants and 45 passengers aboard the airplane died; one person on the ground died; and the airplane was destroyed by impact and fire.
